GROUNDWATER/SURFACE WATER MONITORING AT
KARWYDESKRAAL LANDFILL SITE – NOVEMBER 2010
MONITORING

CLIENT: OVERBERG DISTRICT MUNICIPALITY

PROJECT NO. 1031

REPORT NO.: B2011-02_01

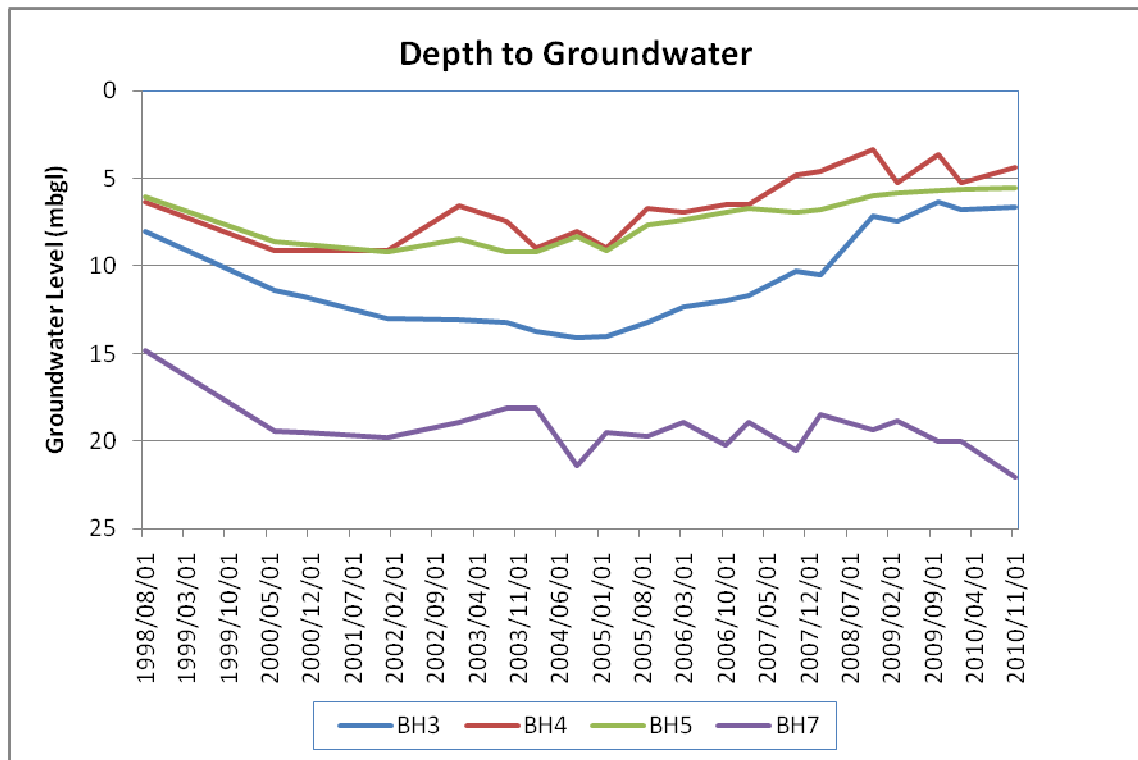
Figure 6: Groundwater Level Depth

The time series water level data of boreholes BH3, BH4, BH5 and BH7 are graphically displayed in Figure 6. From 1998 to 2010, the water levels at BH3, BH4 and BH5 show similar trends. The water levels at the latter boreholes showed a steady decline from 1998 to 2005 (i.e. 3 – 6 m), followed by a steady recovery period from 2005 to 2010 to above the 1998 level. BH7 has a slightly different trend. Whilst the water level at BH7 also shows an initial downward trend of about 5 m from 1998 to 2005, this was followed by a period of stable water levels (i.e. at about 20 mbgl) from 2005 to 2009, as well as a further water level decline of about 2 m from 2009 to 2010.

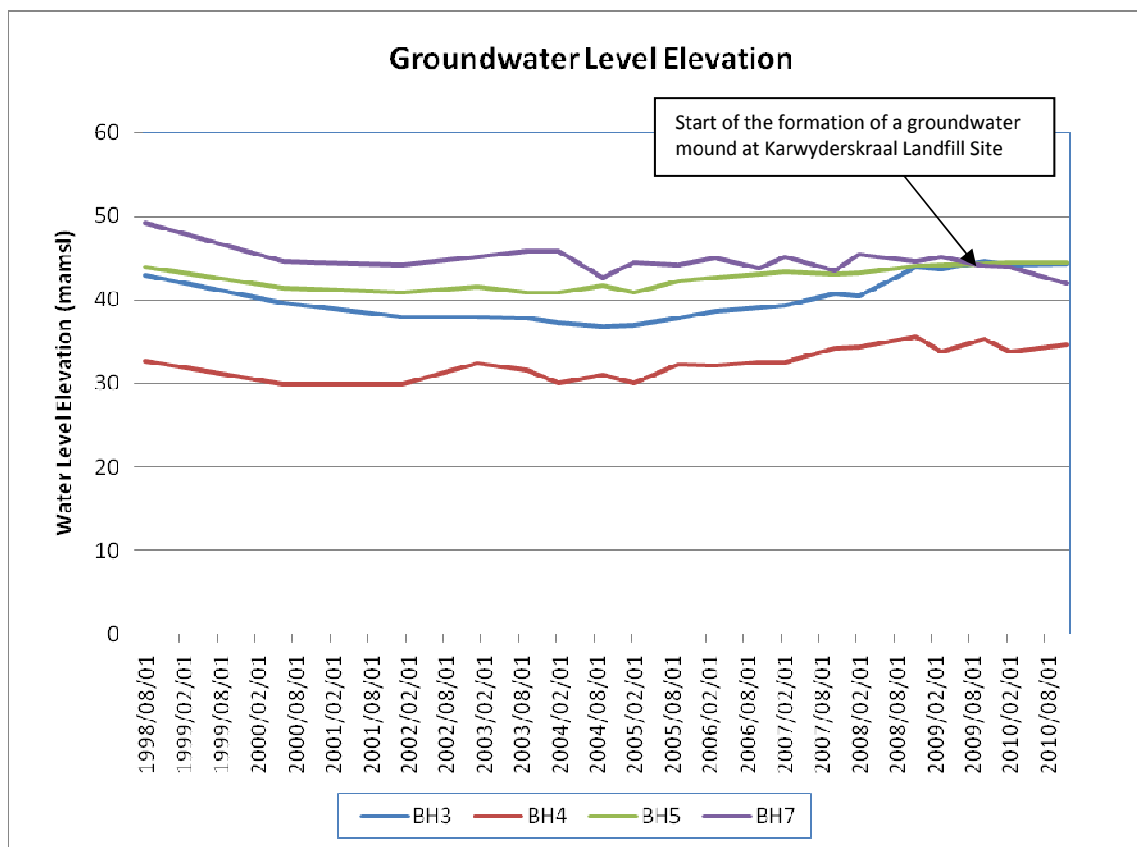
Figure 7: Groundwater Level Elevation

BH7 is situated upgradient of the Karwyderskraal Landfill Site and represents the pristine condition monitoring. BH3, BH4 and BH5 are situated downgradient of the Karwyderskraal Landfill Site. Figure 7 shows the groundwater level elevations for the 4 boreholes visited. Note that these groundwater level elevations are based on surface elevation measurements taken with a handheld Garmin GPS device. Generally, the basic handheld Garmin GPS's don't record accurate surface elevations (i.e. measurements could be out by 3 – 5 m), but they are useful for comparison between different areas. From Figure 7, an interesting observation is that since about November 2009 the groundwater

elevation at BH7 (42 mamsl) has declined to about 2 m below the groundwater elevation at BH3 (44 mamsl) and BH5 (44 mamsl). As a result of this, a groundwater mound has developed in the vicinity of the Landfill Site, which will further result in a reversal in the groundwater flow direction from the Landfill Site towards BH7. The reasons for the groundwater mound developing are:

- Artificial leachate recharge from the Karwyderskraal Landfill Site along preferred pathways (transmissive zones).
- Artificial recharge from the surface stream along preferred pathways (transmissive zones).
- A combination of the two above.

- BH3 must not be used as a production borehole as this could reverse the groundwater flow direction from the Landfill Site towards BH3.
- Pump BH5 to reduce the groundwater mound below the main landfill area and restore the natural flow of groundwater.

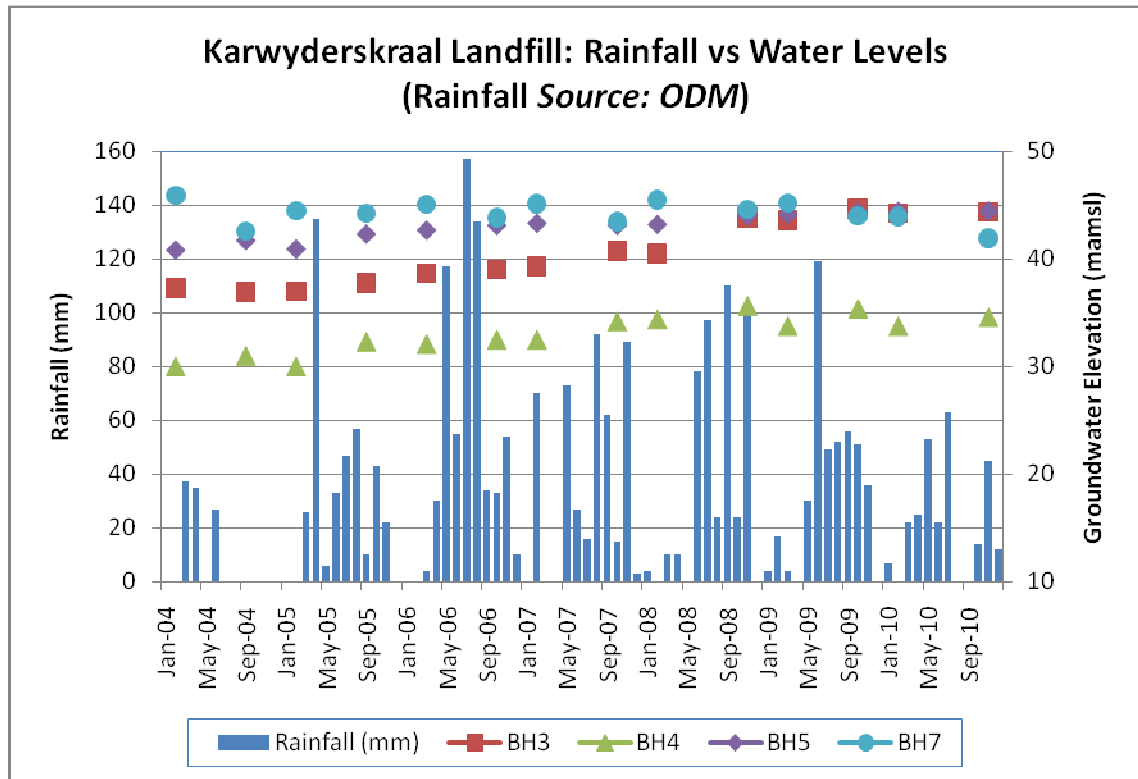
Figure 8: Rainfall vs Water Level Elevation

Figure 8 shows the groundwater level elevations in comparison with the rainfall at Karwyderskraal Landfill Site. The higher rainfall received during 2006 (628 mm), 2007 (447 mm) and 2008 (456 mm) respectively resulted in significant groundwater level recovery at BH3, BH4 and BH5, whilst at BH7 the groundwater level remained stable.

The low rainfall (i.e. 263 mm/annum) received in 2010 did not result in any major groundwater level decline at BH3, BH4 and BH5. The only groundwater

decline was observed at BH7, where the groundwater level declined by about 2 m from end – 2009 to end – 2010. The groundwater levels at BH3, BH4 and BH5 have been very stable since September 2008.

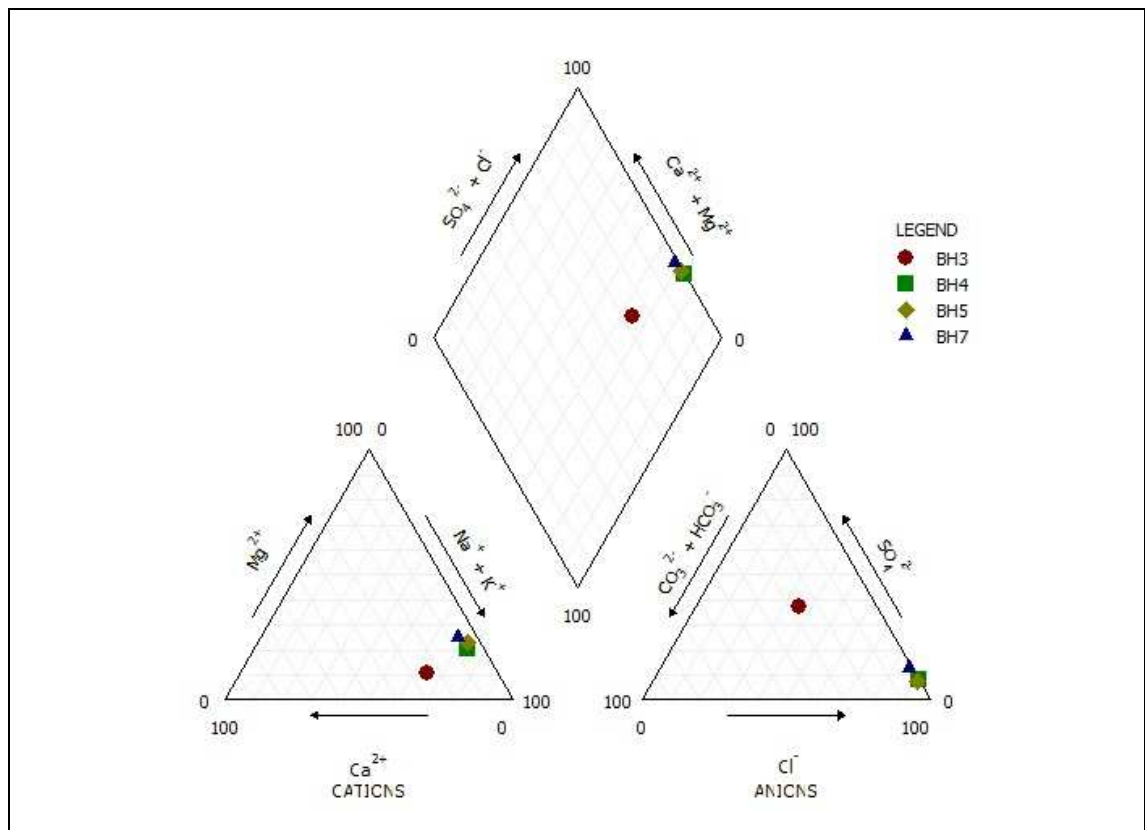
Figure 9: Piper Diagram of Borehole Sites

The water chemistry of the 4 boreholes sampled at the Karwyderskraal Landfill Site is shown in Figure 9. Boreholes BH4, BH5 and BH7 have similar water chemistries, i.e. sodium (Na) and chloride (Cl) dominant ions. The latter boreholes are completely deficient in bicarbonate (HCO_3^-). BH3 has a slightly different chemistry. Whilst BH3 also has sodium (Na) and chloride (Cl) dominant ions, it is also slightly more bicarbonate enriched than the other boreholes, which is generally indicative of a fresher water type.

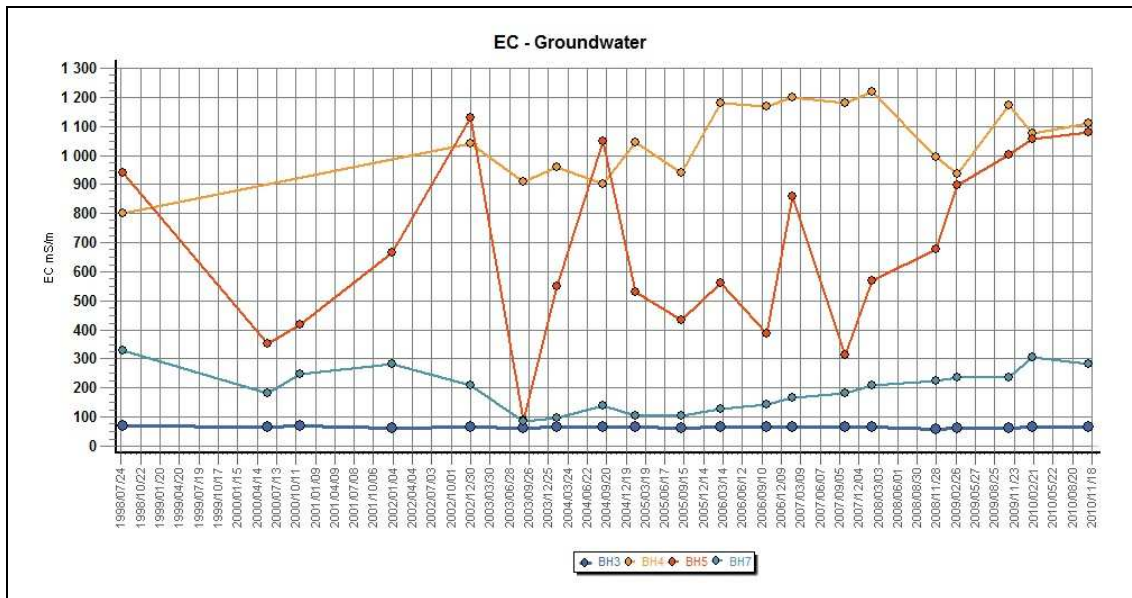
Figure 10: EC of Borehole Sites

The time series EC graph in Figure 10 shows the variation in EC over time. BH3 has the lowest and most stable EC of the 4 boreholes sampled, i.e. between 60 – 70 mS/m. The EC at BH7 varies between 100 mS/m and 300 mS/m. Since 2005 a gradual increase in EC has been observed at BH7. The EC at BH4 and BH5 are significantly higher and have greater variability than at BH3 and BH7. The EC at BH4 varies between 800 – 1200 mS/m, whilst the EC at BH5 varies between 100 – 1100 mS/m.

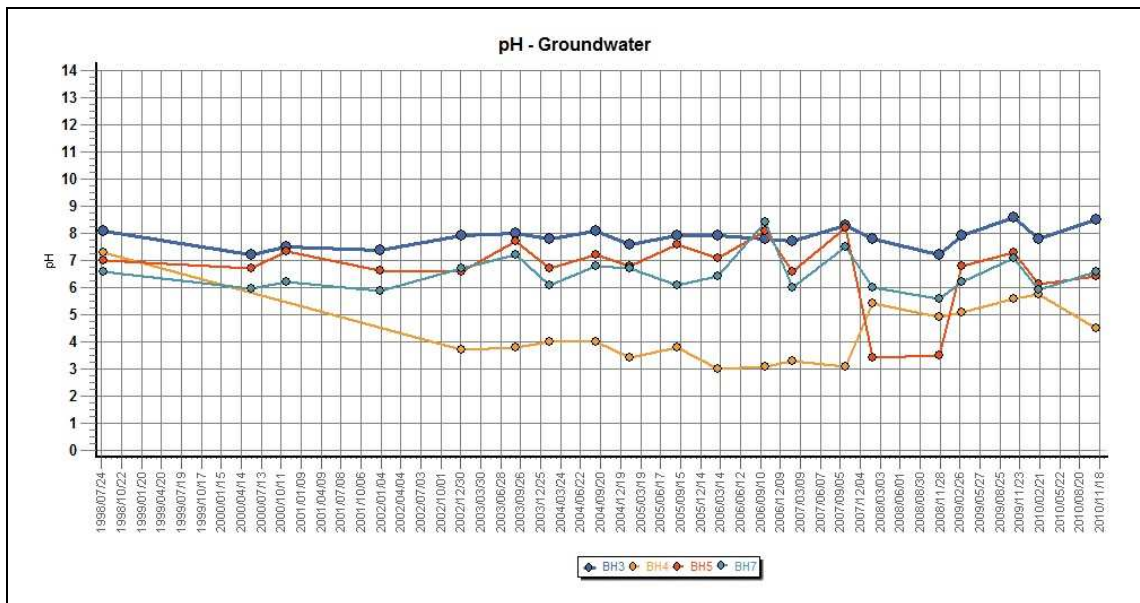
Figure 11: pH of Borehole Sites

The pH at BH3 is relatively stable between 7 and 8.5 (Figure 11). In contrast, greater variations in pH are observed at BH4 (i.e. 3 – 7.5), BH5 (i.e. 3.5 – 8) and BH7 (i.e. 5.5 – 8). BH4 and BH5, in particular, show sharp periodic variations in pH, particularly since 2007.

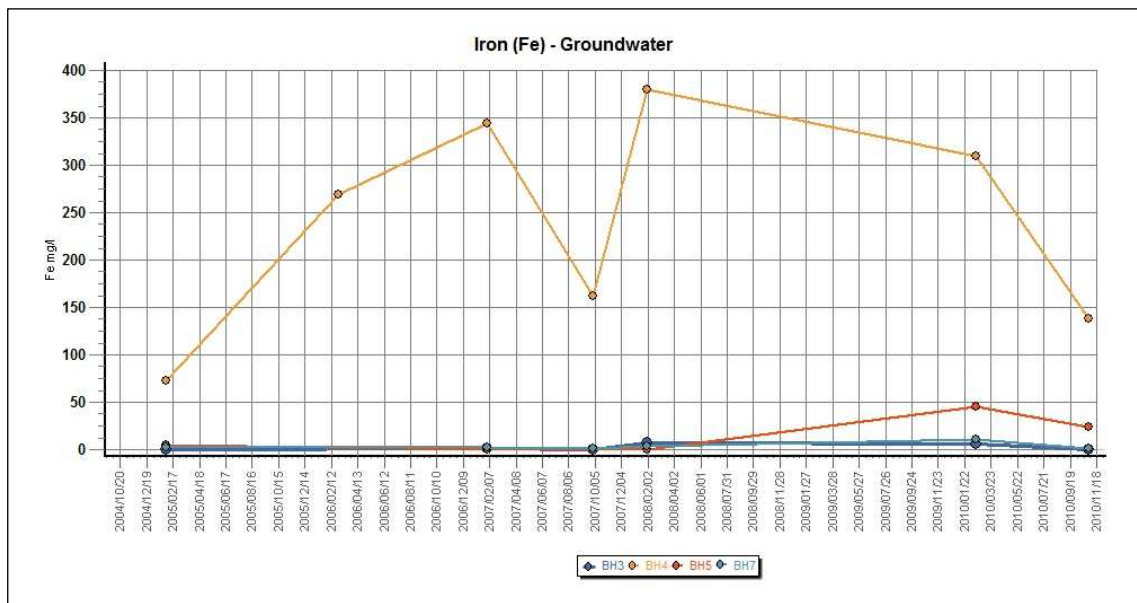
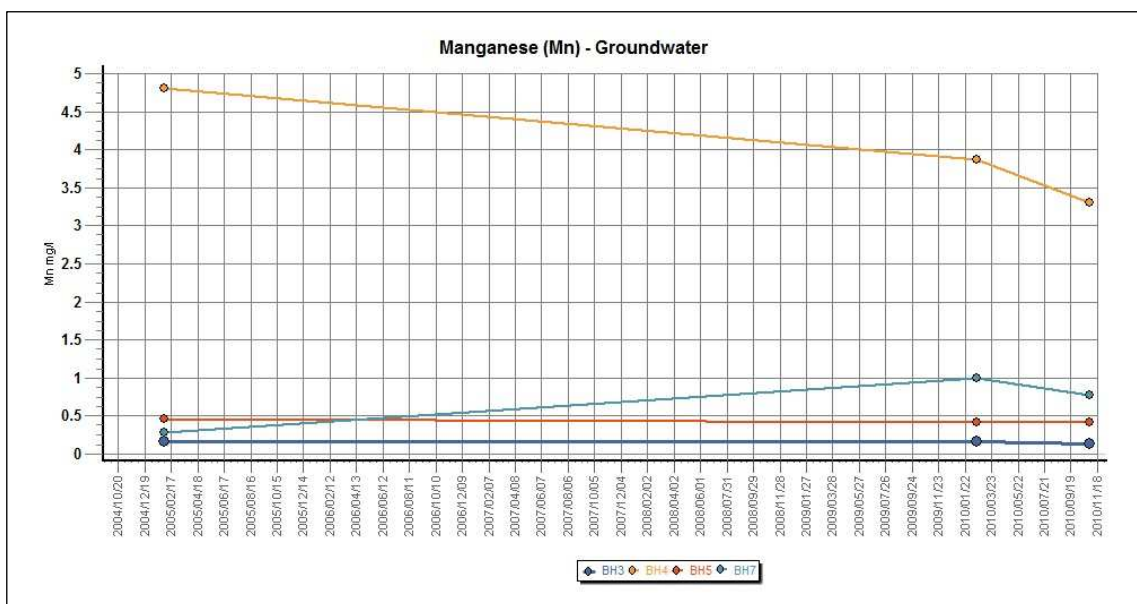
In terms of the heavy metal content, the latest Fe and Mn concentrations are high at BH5 (i.e. 24.0 mg/l and 0.4 mg/l respectively) and extremely high at BH4 (137.0 mg/l and 3.0 mg/l respectively) (Figures 12 and 13). Generally, water used for domestic purposes should have Fe and Mn concentrations of < 1.0 mg/l and 0.1 mg/l respectively (DWA, 1999). The exceptionally high Fe

and Mn concentrations observed at BH4 and BH5 are likely to be related to a pollutant source from the Karwyderskraal Landfill Site. At BH7, slightly elevated Fe and Mn concentrations are recently observed, i.e. 1.6 mg/l and 0.7 mg/l respectively. However, note that the Fe and Mn concentrations at BH7 were > 10.0 mg/l and 0.99 mg/l respectively in February 2010, which could be indicative of leakage of poorer quality groundwater. At BH3 the latest Fe and Mn concentrations are 0.09 mg/l and 0.14 mg/l respectively. However, it must be noted that higher Fe concentrations of > 5.0 mg/l were observed in February 2008 and February 2010 respectively.

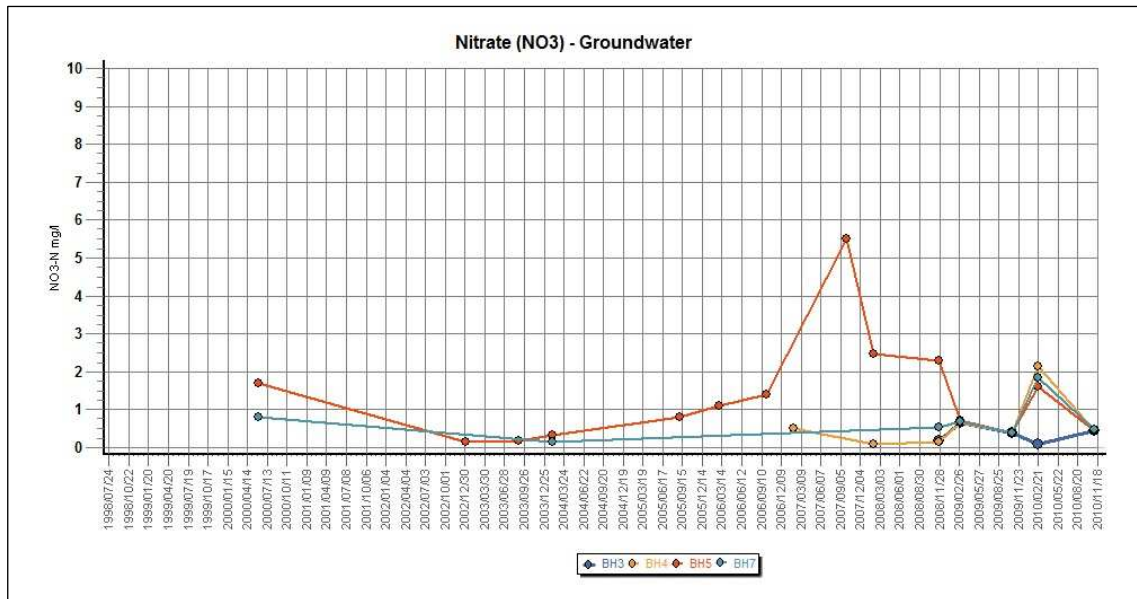
Figure 14: Nitrate (NO₃) in Groundwater

The time series NO₃ and NH₄ data are graphically displayed in Figures 14 and 15. At all boreholes the NO₃ concentrations have been below the recommended 6.0 mg/l prescribed by DWA for drinking water standards (DWA, 1999). Generally the NO₃ concentrations are relatively stable throughout the monitoring record. An occasional spike occurred at BH5 during 2007 and 2008, where the NO₃ concentration increased to > 5.0 mg/l. However, the latest NO₃ concentrations at all the boreholes are < 1.0 mg/l.

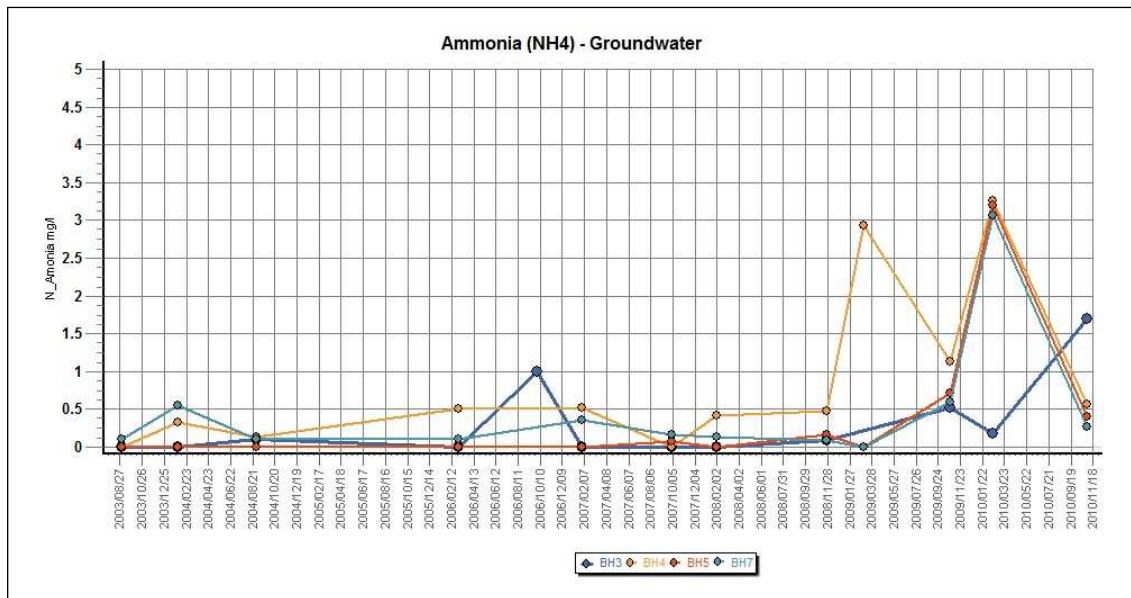
Figure 15: Ammonia (NH₄) in Groundwater

The NH₄ concentrations at BH4, BH5 and BH7 have similar recent (2009 – 2010) trends. Prior to 2009, the NH₄ concentrations at all boreholes were generally < 1.0 mg/l. However, in 2009 a sharp increase in NH₄ concentration was observed at BH4, BH5 and BH7 to about 3.0 mg/l, whilst that of BH3 remained < 1.0 mg/l. The latest NH₄ concentration at BH4, BH5 and BH7 is < 1.0 mg/l, whilst that of BH3 has increased to > 1.5 mg/l.

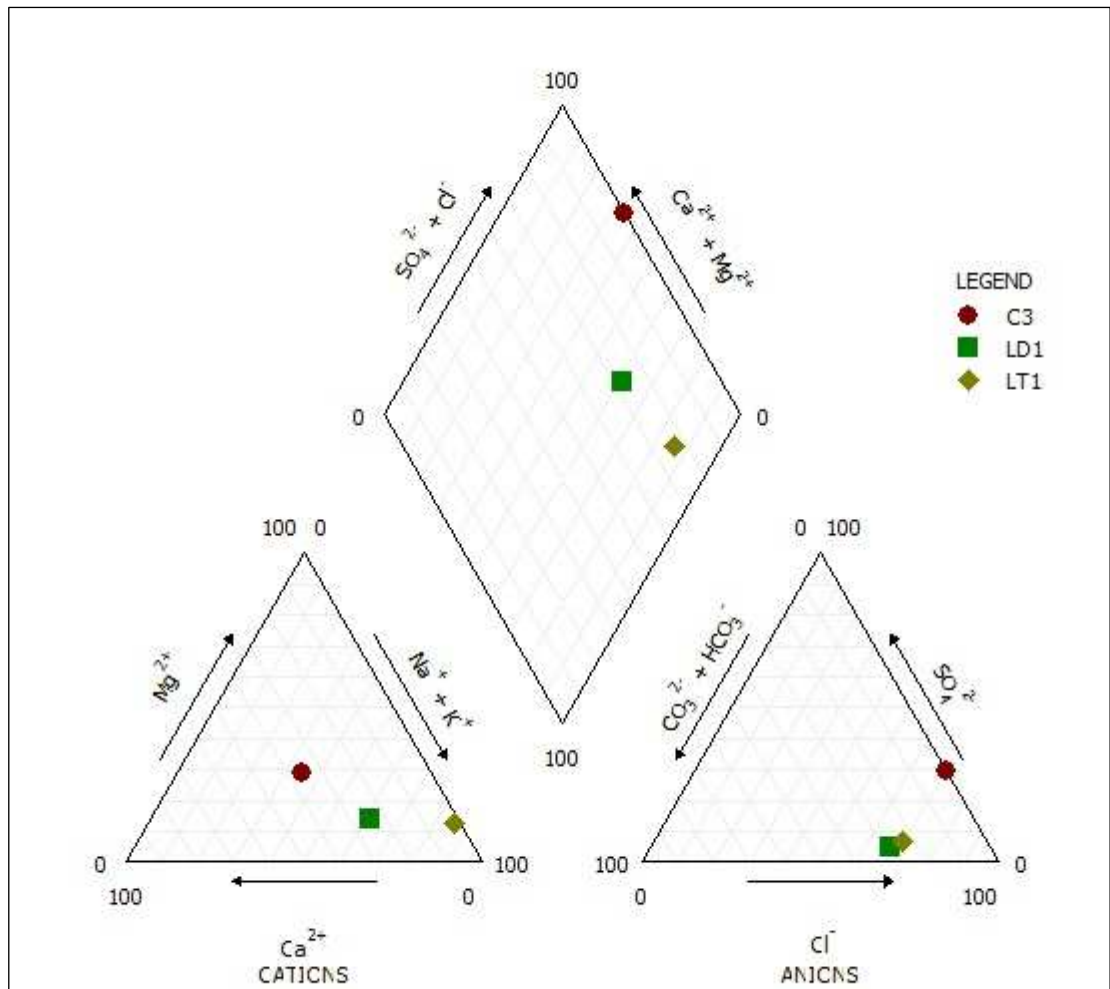
Figure 16: Piper Diagram of Leachate Sites

The water chemistry of the 3 leachate sites at the Karwyderskraal Landfill Site is shown in Piper Diagram (Figure 16). Of these 3 sites, only LT1 was sampled during the November 2010 sampling run. LD1 could not be sampled due to an obstacle in the downpipe, whilst C3 was dry. The data reflected in the Piper Diagram is based on the latest measured dataset at these 3 sites.

As expected the 3 leachate sites have different chemistries, mainly due to their different settings. LT1 monitors the leachate above the clay liner, whilst LD1 monitors the leachate below the clay liner (GEOSS, 2010). C3 monitors the overland flow from a stormwater compost window (GEOSS, 2010). LT1 is exclusively sodium (Na) – chloride (Cl) dominant water type, depleted in calcium (Ca), magnesium (Mg) and bicarbonate (HCO₃). LD1 has predominantly sodium (Na) – chloride (Cl) dominant water type, but is more enriched in calcium (Ca) and magnesium (Mg) than LT1. LD1 plots very close to BH3 (See Section 6.1) and could reflect the natural water type in the aquifer. C3 has a calcium (Ca), magnesium (Mg) and chloride (Cl) water type.

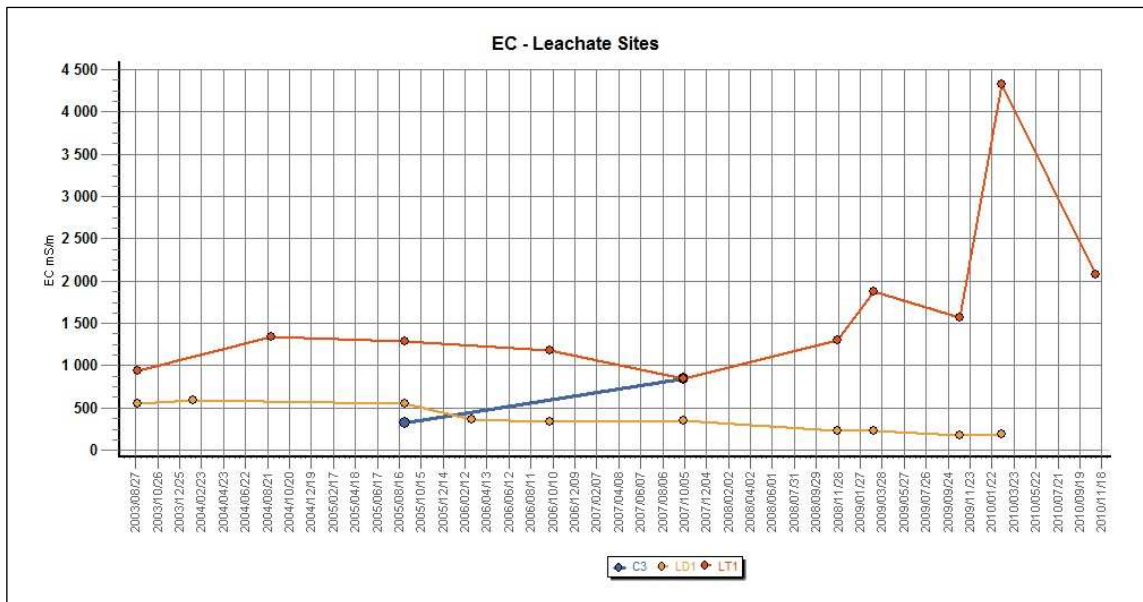
Figure 17: EC of Leachate Sites

The EC graph for the leachate sites is shown in Figure 17. The EC at LT1 varies significantly between 1000 – 4500 mS/m. The EC at LD1 varies between 170 – 550 ms/m, but more importantly, there has been a consistent decrease in EC since 2004 to the latest 187 mS/m level. C3 was only sampled twice before and no clear trend in EC can be observed. The latest EC, measured in 2007, was > 500 mS/m.

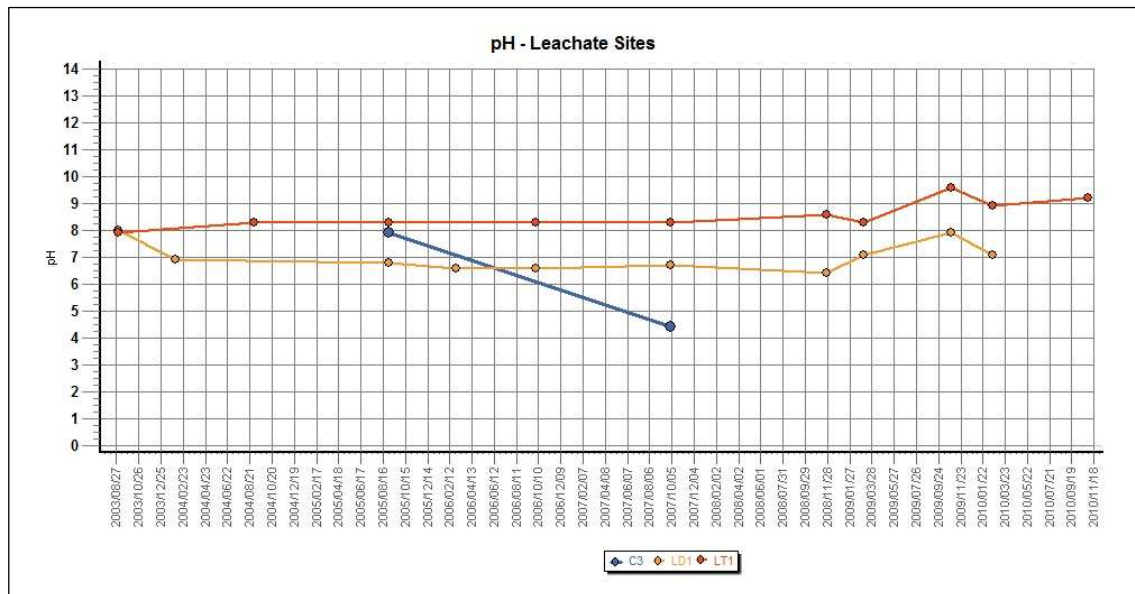
Figure 18: pH of Leachate Sites

The long-term trend in pH between LT1 and LD1 is similar (Figure 18). However, the pH at LT1 is consistently higher than that of LD1. The pH at LT1 varies from 8.0 – 9.5, whilst the pH at LD1 varies from 6.5 – 8.0.

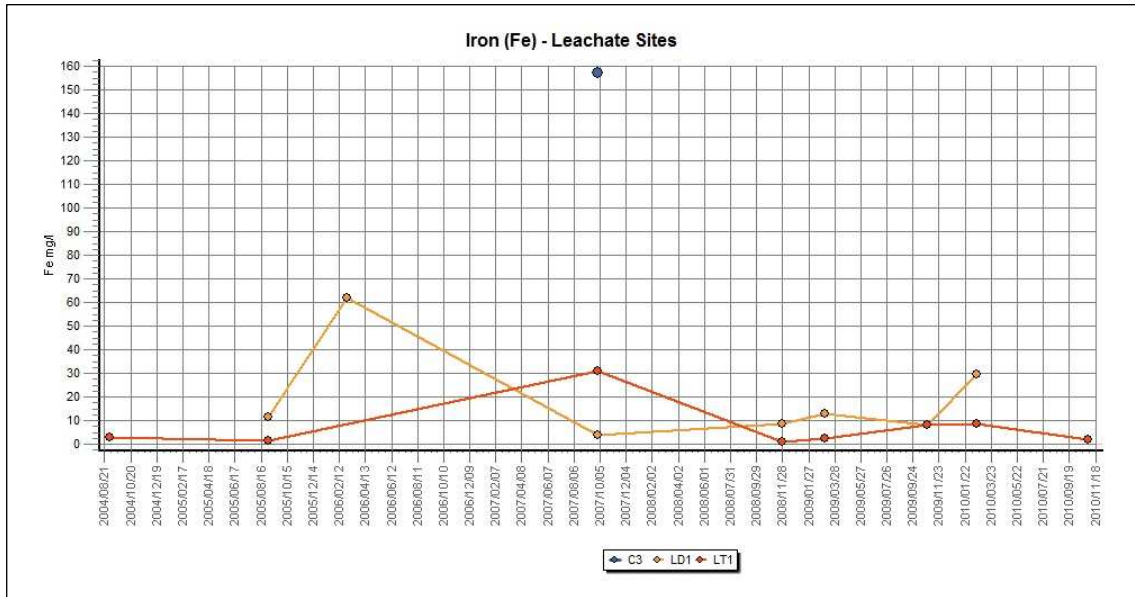
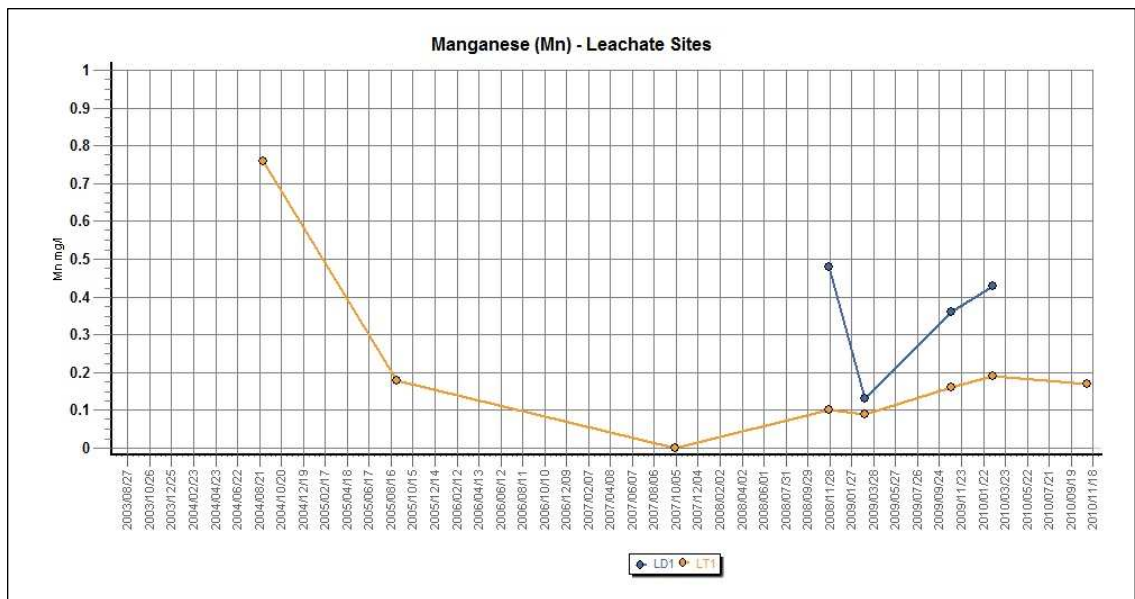
The observed Fe and Mn concentrations correlate well with that of the borehole sites (Figures 19 and 20). At LD1 the Fe and Mn concentrations are between 5 – 60 mg/l and 0 – 0.80 mg/l respectively, whilst at LT1 the Fe concentrations are between 2 – 30 mg/l. Similar ranges in Fe and Mn concentrations were observed at BH5 and to a lesser extent BH7. The exception is at C3, where the Fe concentration of > 150 mg/l was recorded in 2007. However, Fe at BH4 was

also > 150 mg/l during this period, which suggests that leakage from the stormwater compost window (C3) into the groundwater is occurring.

- Future monitoring at LD1 and BH3 must be handled with care. Any significant signs of contamination at LD1 must be mitigated immediately to prevent the leakage of contaminants to BH3.

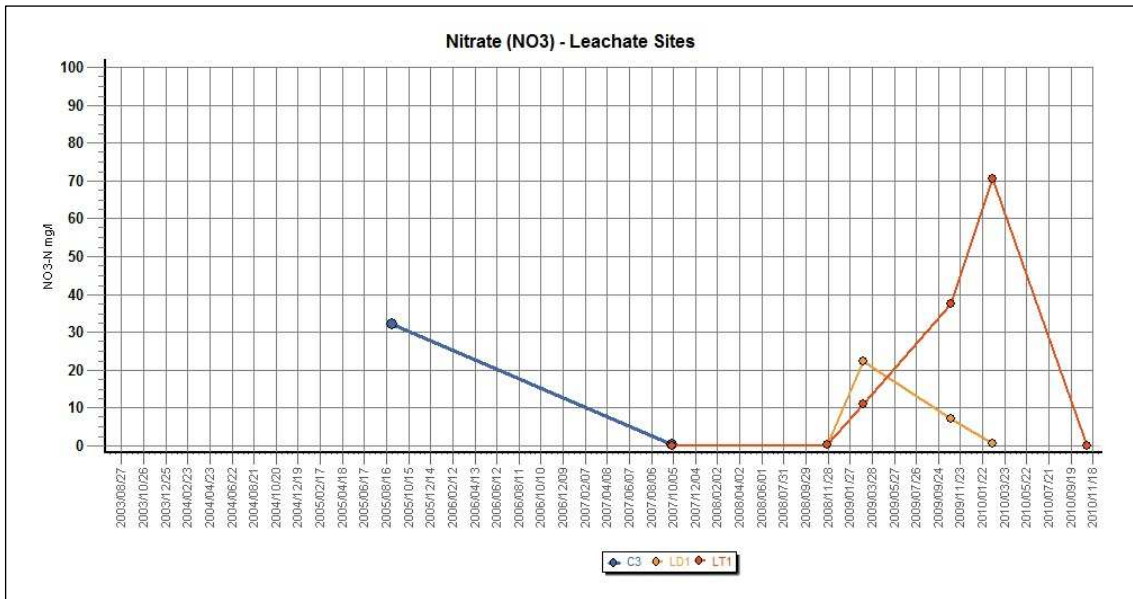
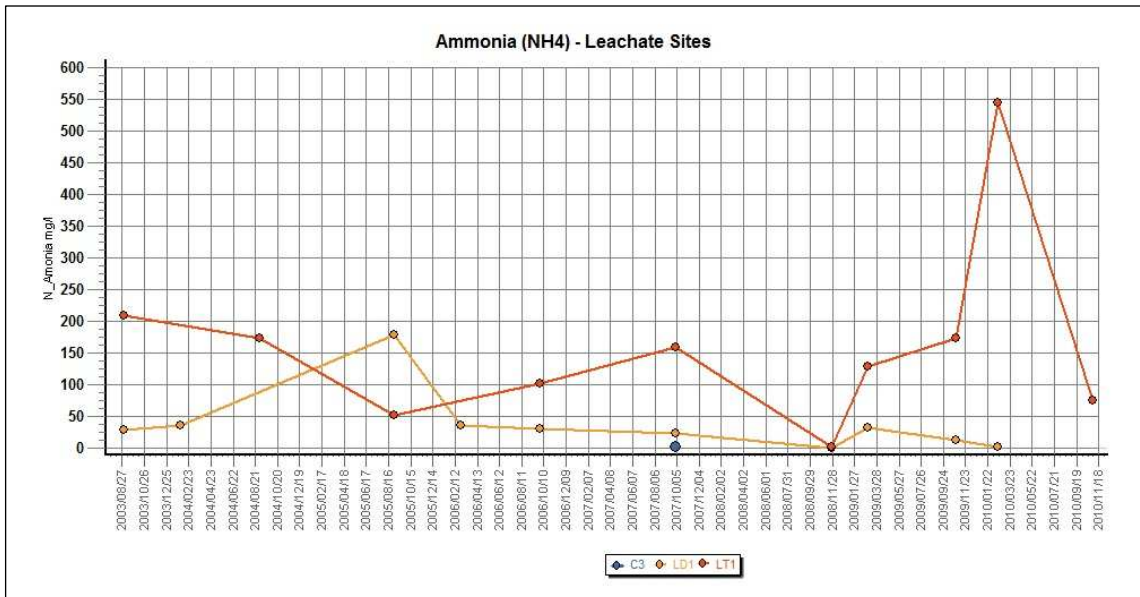
The NO₃ and NH₄ concentrations tend to fluctuate significantly at LT1, where a peak NO₃ and NH₄ concentrations of > 70 mg/l and 550 mg/l respectively were recorded in February 2010 (Figures 21 and 22). The NO₃ concentration at LD1 was only once over the 10 mg/l (i.e. maximum allowable concentration for domestic water purpose) mark during February 2009, whilst the NH₄ concentration is showing a steady decline to its latest level of < 10 mg/l.

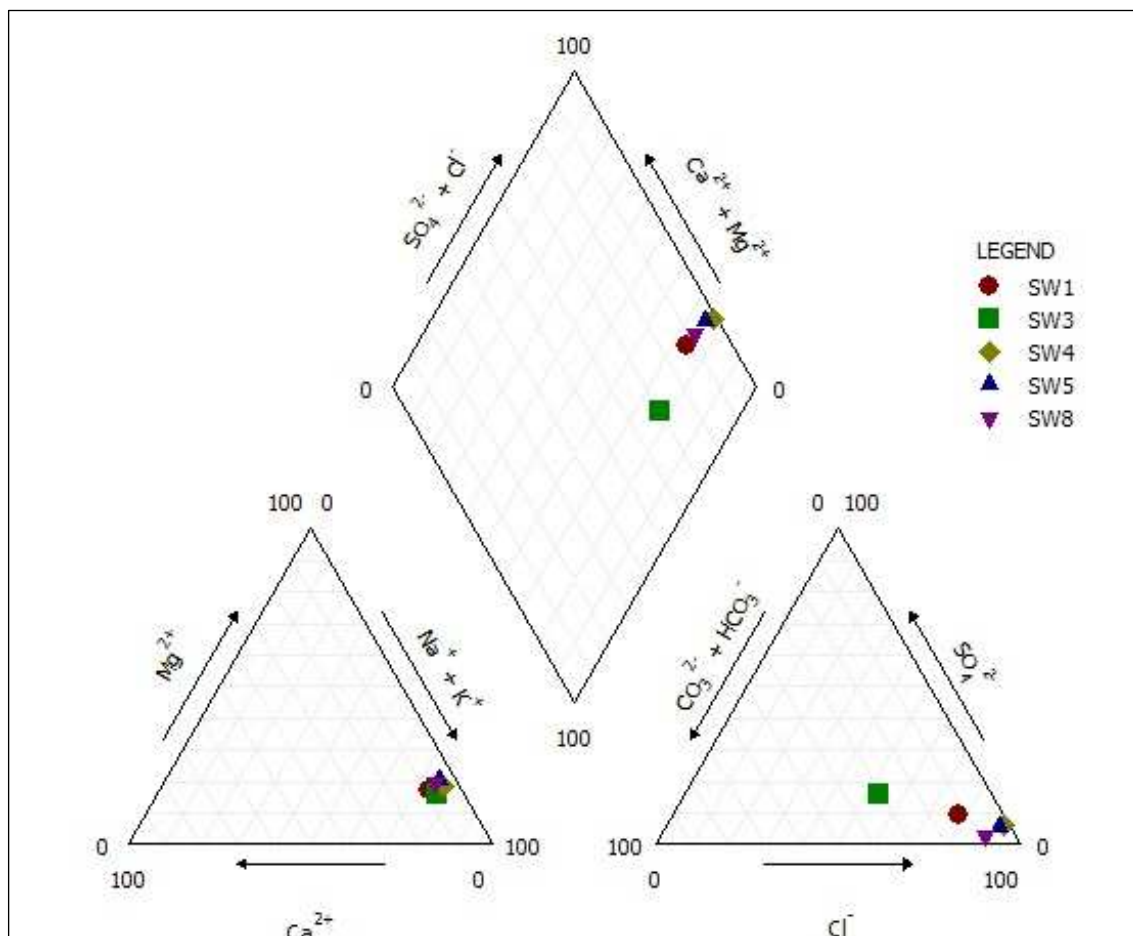
Figure 23: Piper Diagram of the Surface Water Sites

The water chemistry of the 5 surface water sampling sites sampled at the Karwyderskraal Landfill Site is shown in Figure 23. SW1, SW4, SW5 and SW8 have similar water chemistries, i.e. sodium (Na) and chloride (Cl) dominant ions. The latter sites are almost completely deficient in bicarbonate (HCO_3). SW3 has a slightly different chemistry. Whilst SW3 also has sodium (Na) and chloride (Cl) dominant ions, it is also slightly bicarbonate enriched, which is generally indicative of a fresher water type. SW3 has a similar water chemistry than BH3 (see 6.1) and LD1 (see 6.2).

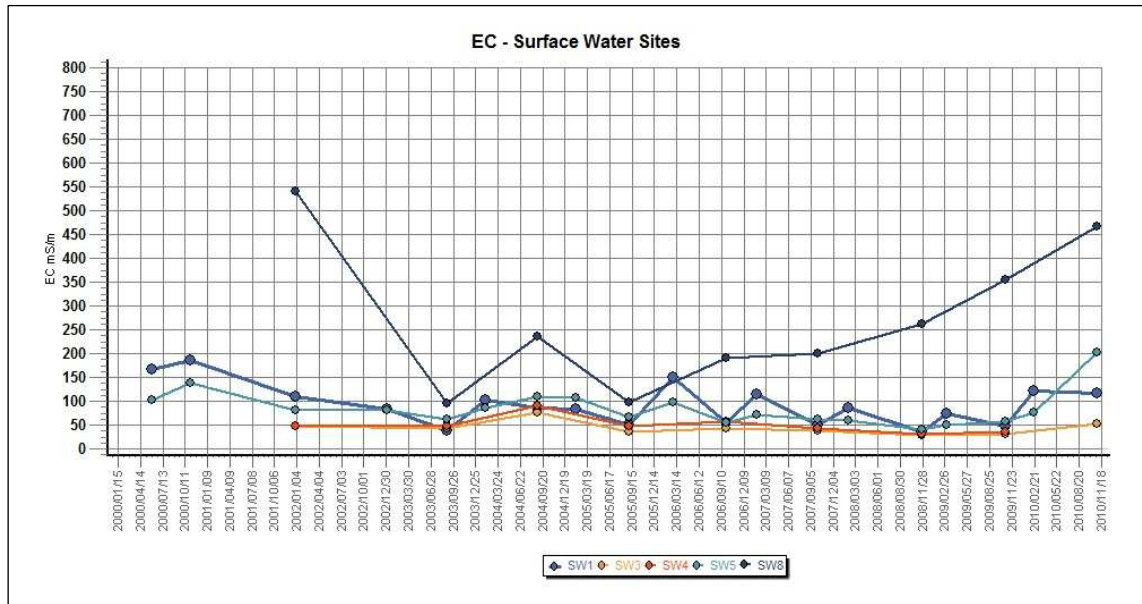
Figure 24: EC at Surface Water Sites

The EC at most of the surface water sites have similar trends (Figure 24). The only exception is at SW8. The EC at SW8 is generally at least 2 – 3 times greater than at all the other surface water sites. Since 2006, the EC at SW8 has increased steadily from about 200 mS/m to 450 mS/m. Note that the ECs at SW1, SW3, SW4 and SW5 vary between about 50 mS/m to 200 mS/m, but in

some instances the EC might have been impacted by cattle grazing at these sites.

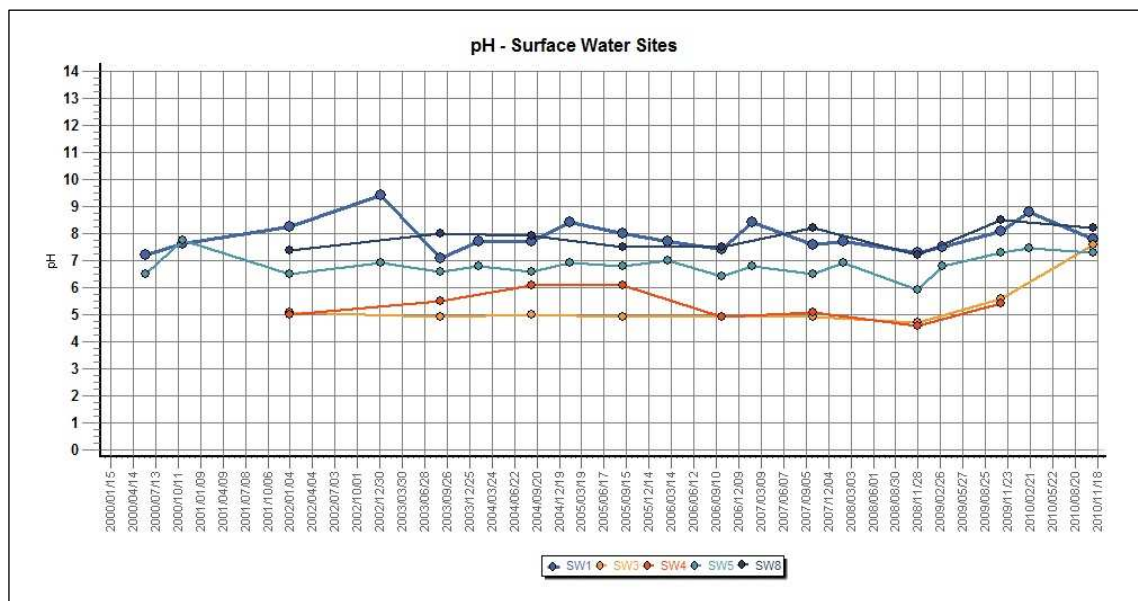
Figure 25: pH at Surface Water Sites

The pH at the surface water monitoring sites varies between 5 and 9 (Figure 25). The lowest pH of between 5.0 and 6.0 can be observed at SW3 and SW4, which is situated downstream of the Karwyderskraal Landfill Site. The pH at SW5 is slightly elevated at between 6.0 and 7.5. The pH at SW1 (upstream of Karwyderskraal Landfill Site) and SW8 (directly below the main Landfill area) are generally between 7.0 and 9.0.

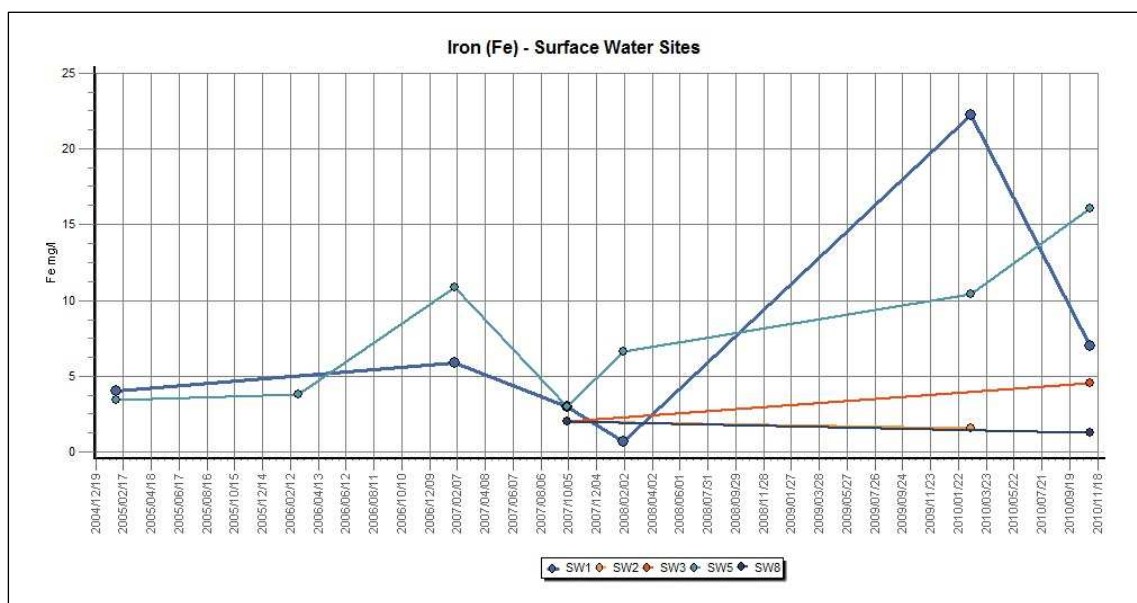
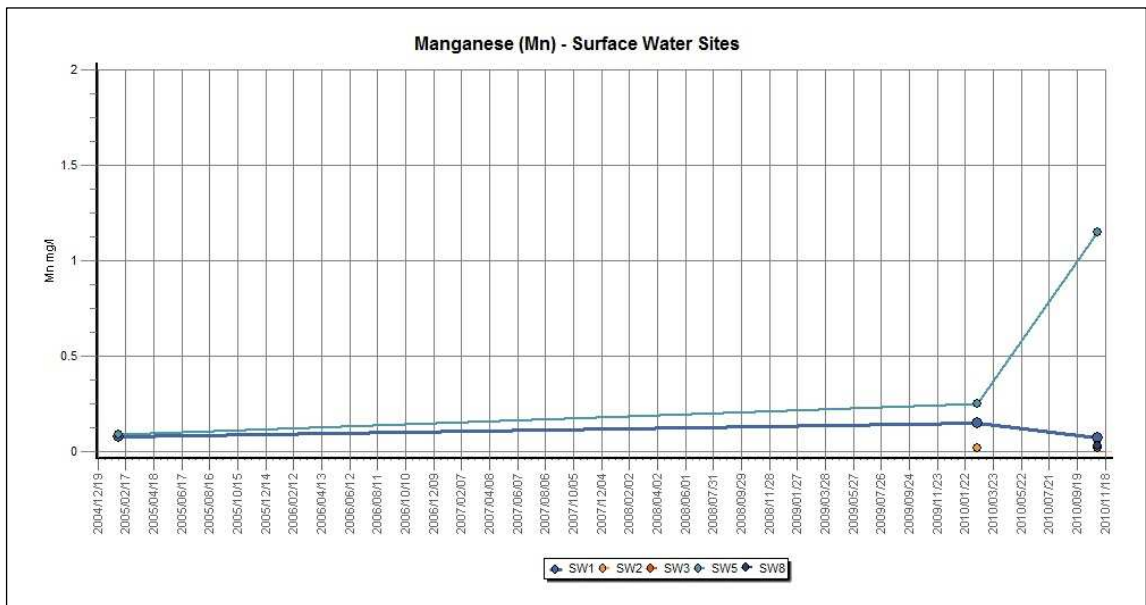
From Figures 26 and 27, the Fe and Mn concentrations are highest at the upper and lower most surface water monitoring points, i.e. SW1 (22 mg/l) and SW5 (16 mg/l) respectively. Ironically both these sites are enclosed water bodies (most if not all of the time) or non – flowing monitoring points, which could be prone to pollution from other sources such as cattle and human/farming activities. At the other monitoring sites, i.e. SW2, SW3 and SW8, the Fe and Mn concentrations are well below 5.0 mg/l. Hence, the periodic increase in the Fe and Mn observed at SW1 and SW8 are more likely to be related to another pollutant source other than the leachate from the Karwyderskraal Landfill Site.

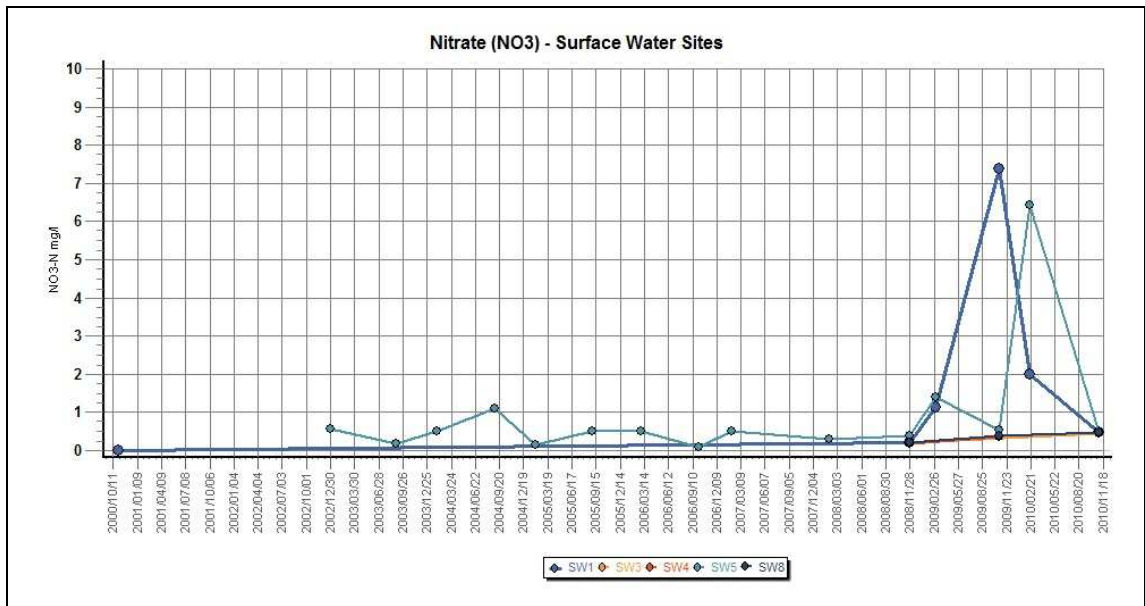
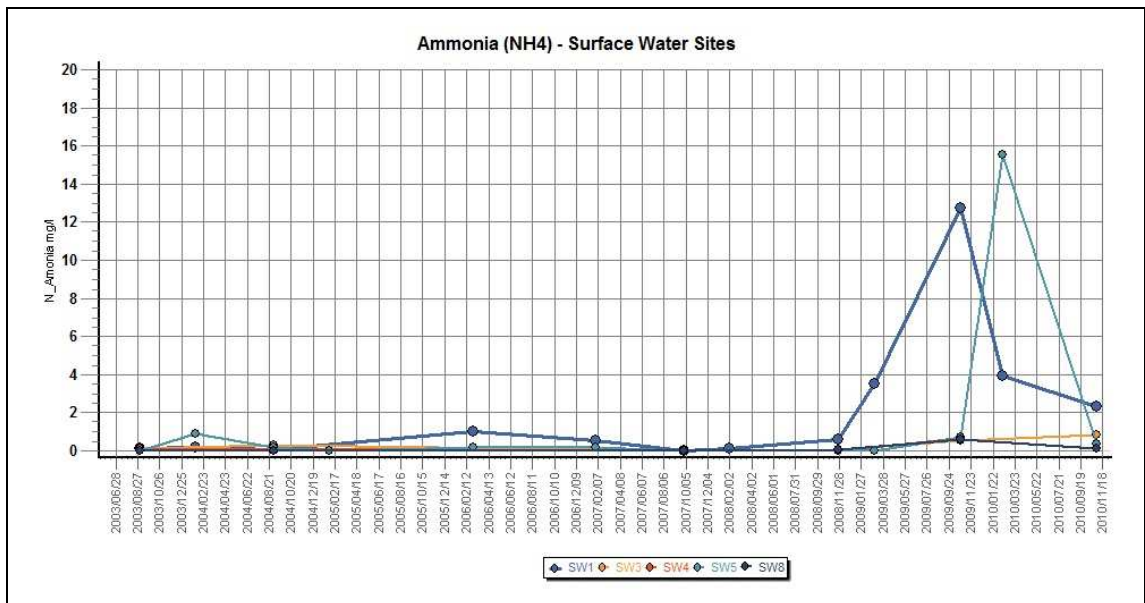
A similar trend observed with the heavy metals (Fe and Mn) are observed with the NO₃ and NH₄ concentrations at the surface water sites (Figures 28 and 29). A periodic increase in the NO₃ and NH₄ concentrations were observed at SW1 and SW8 from end – 2009 to end – 2010. At all the other monitoring sites the NO₃ and NH₄ concentrations are both below 1.0 mg/l. The latter confirms that the surface water monitoring sites SW1 and SW5 could periodically become polluted by either cattle or human/farming activities, which is entirely independent from the Karwyderskraal Landfill Site. Closer to the Karwyderskraal Landfill Site, the monitoring sites SW2 and SW3 are not showing signs of any pollution. Surprisingly, SW8 is also not showing signs of significant NO₃ and NH₄ pollution since it is situated close to and downgradient of the main Landfill area.
